Your Whole Inspection Report

Your Whole House, Inc.
1319 Hammann Drive
Amelia, Ohio 45102
513-752-5018

Client: Jane Doe.
Mailing Address: 7604 Shawn Drive.
Cty,St,Zip Cinti, Ohio 45202.
Phone # 555-1234.
Inspection Address 7542 Tangle Lane.
Cty,St,Zip West Chester, Ohio 45069.
Age Estimated: 26 yrs.
House Construction/Style 2 Story, Wood Framed.
Weather conditions: Sunny.
Aproximate Temperature: 40-50 degrees.

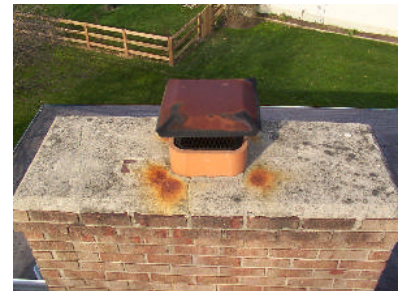
Chimney #1	<i>FAIR</i> , Typical mortar cap cracks, recommend seal or reseal. Cap is too small for flue pipe, Not an adverse condition however recommend proper size.
-------------------	--

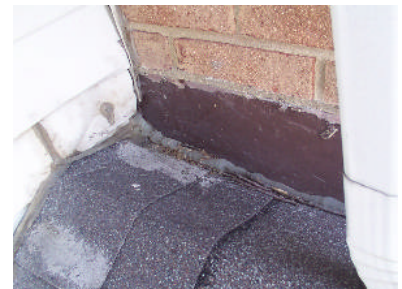
Flashings	<i>FAIR</i> , Tar and caulk present, monitor closely over time.
------------------	---

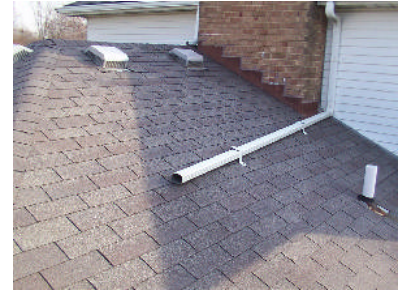
SATISFACTORY, except recommend rear garage roof upper downspout be run directly to gutter.

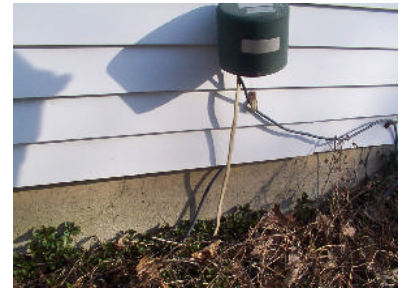
Main siding	<i>SATISFACTORY.</i>
Siding #2	<i>SATISFACTORY.</i>
Windows:	<i>SATISFACTORY.</i>
Entry doors	<i>SATISFACTORY.</i>
Steps	<i>FAIR, Cracks and settlement common.</i>
Deck/Porch #1	<i>FAIR, Typical cracks and settlement.</i>
Electric outlets and fixtures	<i>FAIR, Recommend upgrade outlets to GFCI type. Exposed wires needs protected from damage.</i>

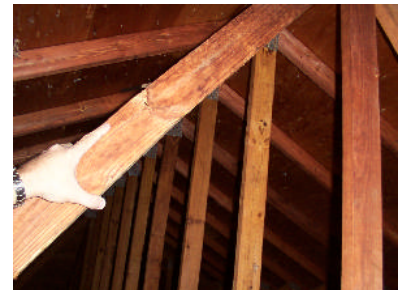
Roof framing	<i>FAIR</i> , broken web member at 2nd floor attic access has broke at a knot. Needs board fastened to side.
---------------------	--

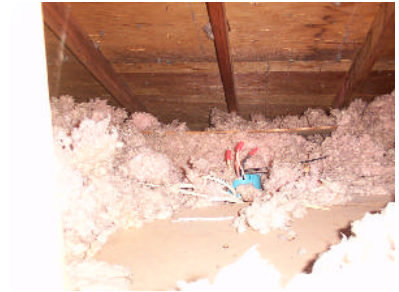
Wire splice towards rear needs to be in an enclosed junction box.

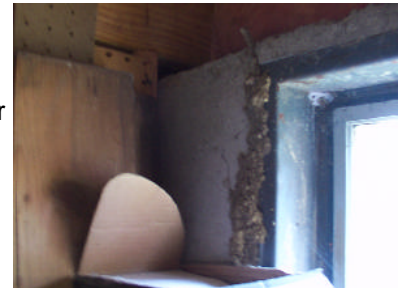
Foundation Walls	<i>FAIR</i> , Typical shrinkage and settlement cracks.
Piers & Columns	<i>SATISFACTORY</i> .
Framing	<i>FAIR</i> , Termite damage noted, what is visible not showing signs of adverse structural conditions. Framing repairs noted under front entry is suspected to be same condition as rear patio door.

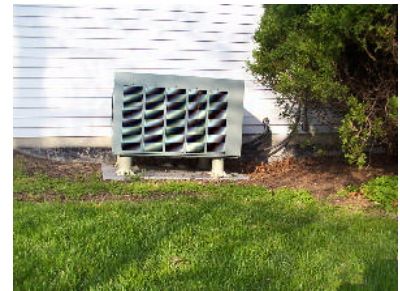
Heating unit #1 FAIR, age. Recommend leveling unit.
